**U.S. ENVIRONMENTAL PROTECTION AGENCY  
TECHNICAL ENFORCEMENT SUPPORT  
AT  
HAZARDOUS WASTE SITES**

**DRAFT PRELIMINARY REVIEW/  
VISUAL SITE INSPECTION REPORT  
CHEMICAL WASTE MANAGEMENT, INC.  
VICKERY, OHIO  
OHD 020 273 819**

**RCRA FACILITY ASSESSMENT  
U.S. EPA REGION V**

**MARCH 1991**

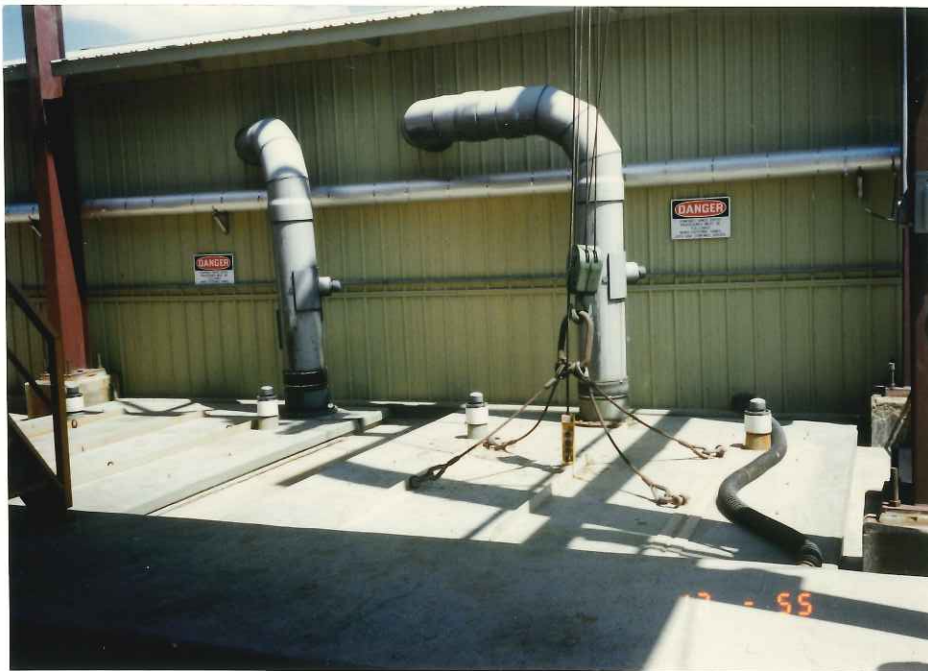
PHOTOGRAPH #5  
 OFFICIAL PHOTOGRAPH - JACOBS ENGINEERING  
 SUBJECT: Two "gravity filter" Interceptor Tanks, in ground  
 LOCATION: Interceptor Tanks  
 DATE: 05/08/90      TIME: 1355  
 PHOTOGRAPHER: L. Ehrhard  
 FILM: Kodacolor ASA 200  
 FILE: 10-E054-00  
 WITNESS: E. Gorove

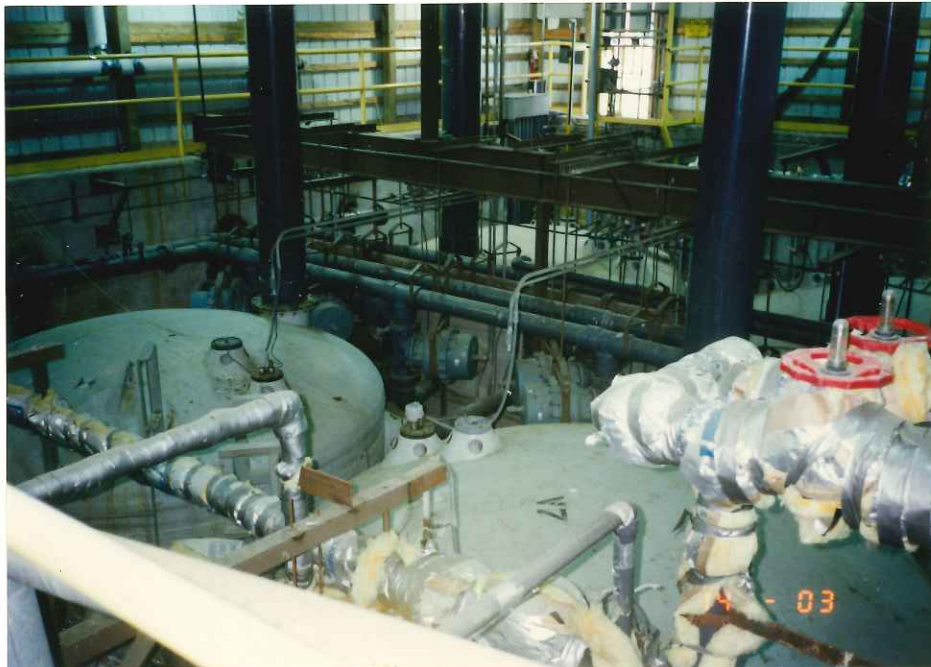
PHOTOGRAPH #6  
 OFFICIAL PHOTOGRAPH - JACOBS ENGINEERING  
 SUBJECT: Four V-Tanks inside covered vault  
 LOCATION: 4 V-Tanks  
 DATE: 05/08/90      TIME: 1403  
 PHOTOGRAPHER: L. Ehrhard  
 FILM: Kodacolor ASA 200  
 FILE: 10-E054-00  
 WITNESS: E. Gorove

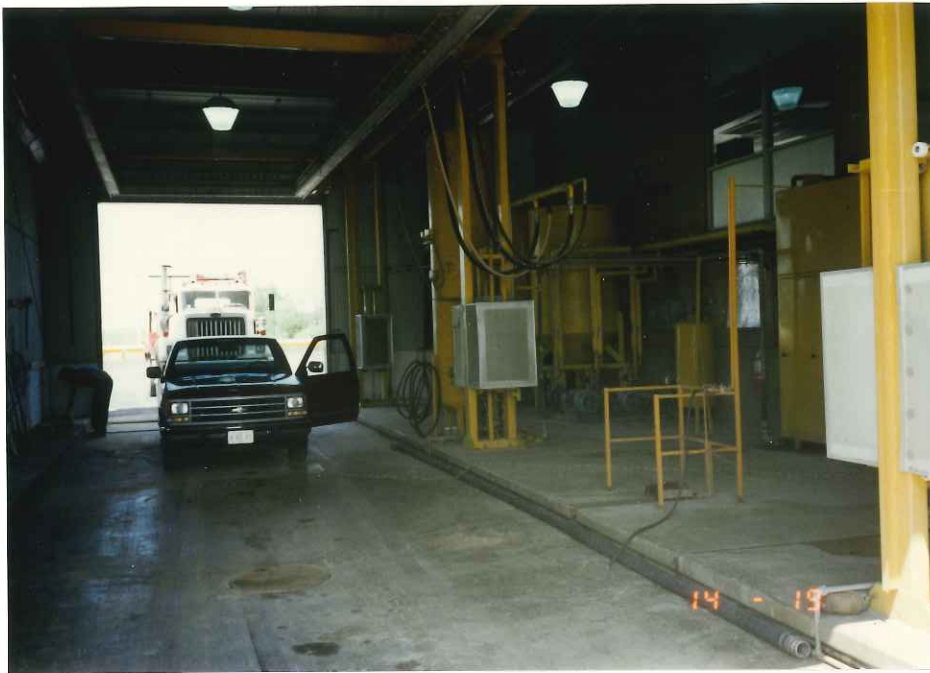
PHOTOGRAPH #7  
 OFFICIAL PHOTOGRAPH - JACOBS ENGINEERING  
 SUBJECT: Inside Truck Washing Facility  
 LOCATION: Truck Washing Facility  
 DATE: 05/08/90      TIME: 1419  
 PHOTOGRAPHER: L. Ehrhard  
 FILM: Kodacolor ASA 200  
 FILE: 10-E054-00  
 WITNESS: E. Gorove

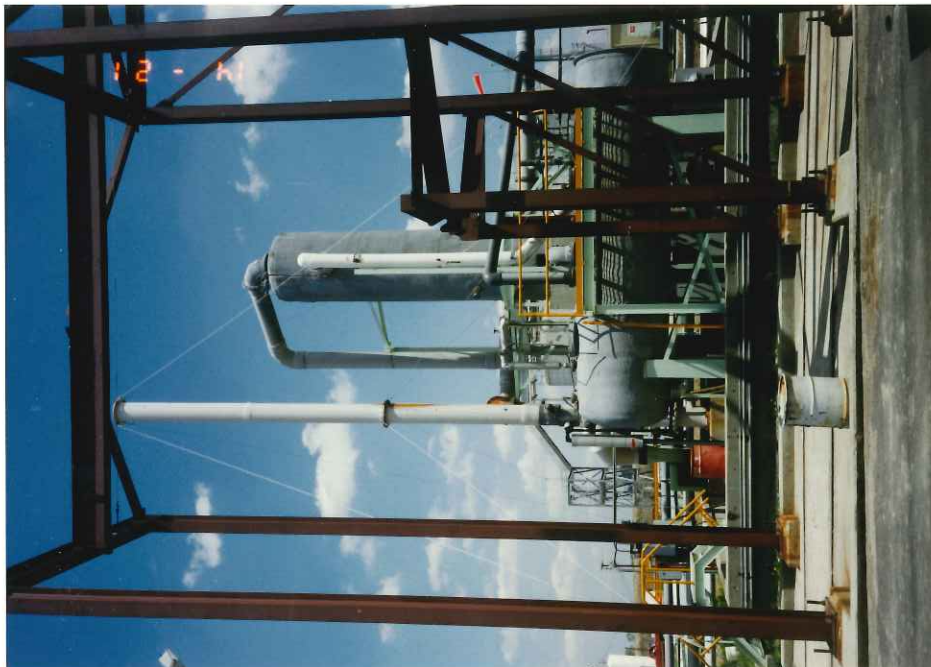
PHOTOGRAPH #8  
 OFFICIAL PHOTOGRAPH - JACOBS ENGINEERING  
 SUBJECT: Air Scrubber and stack  
 LOCATION: Air Scrubber  
 DATE: 05/08/90      TIME: 1421  
 PHOTOGRAPHER: L. Ehrhard  
 FILM: Kodacolor ASA 200  
 FILE: 10-E054-00  
 WITNESS: E. Gorove

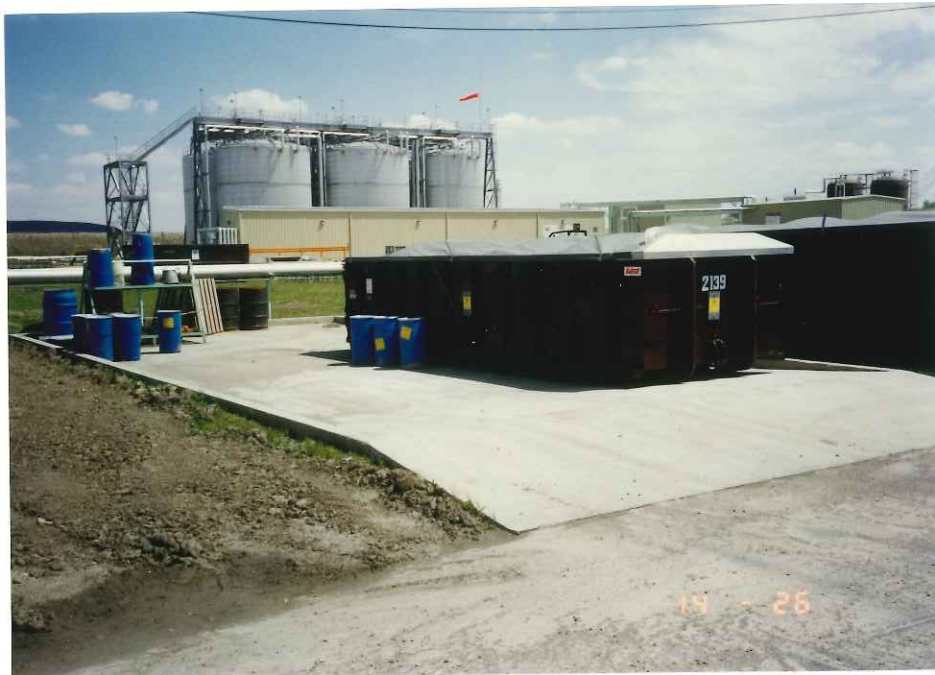
- G. **VSI Observations:** No evidence of releases was noted at the storage pad (photograph #9). However, several large roll-off boxes were observed just south of the pad. Also, drums were being stored at the NW corner of the same parking lot (see Area of Concern <sup>A</sup><sub>B</sub>).

PHOTOGRAPH #9  
 OFFICIAL PHOTOGRAPH - JACOBS ENGINEERING  
 SUBJECT: Bermed, concrete storage pad  
 LOCATION: Drum Accumulation Pad  
 DATE: 05/08/90      TIME: 1426  
 PHOTOGRAPHER: L. Ehrhard  
 FILM: Kodacolor ASA 200  
 FILE: 10-E054-00  
 WITNESS: E. Gorove

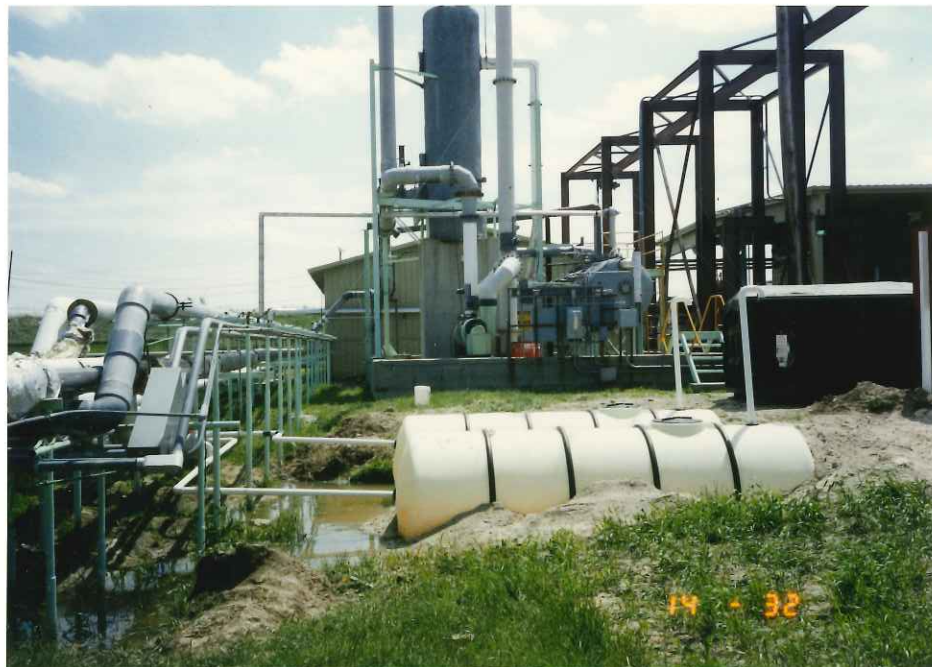
PHOTOGRAPH #10  
 OFFICIAL PHOTOGRAPH - JACOBS ENGINEERING  
 SUBJECT: Above ground maintenance tanks north of Scrubber  
 LOCATION: Maintenance Tanks  
 DATE: 05/08/90      TIME: 1432  
 PHOTOGRAPHER: L. Ehrhard  
 FILM: Kodacolor ASA 200  
 FILE: 10-E054-00  
 WITNESS: E. Gorove

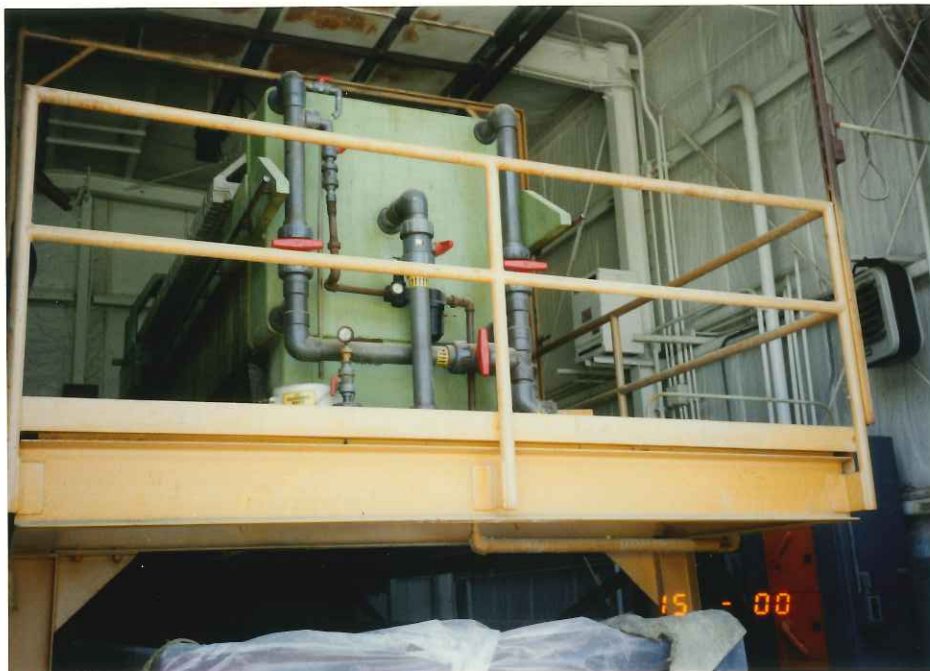
PHOTOGRAPH #13  
 OFFICIAL PHOTOGRAPH - JACOBS ENGINEERING  
 SUBJECT: Filter press inside Filter Building #2  
 LOCATION: Filter Building #2  
 DATE: 05/08/90                      TIME: 1500  
 PHOTOGRAPHER: L. Ehrhard  
 FILM: Kodacolor ASA 200  
 FILE: 10-E054-00  
 WITNESS: E. Gorove

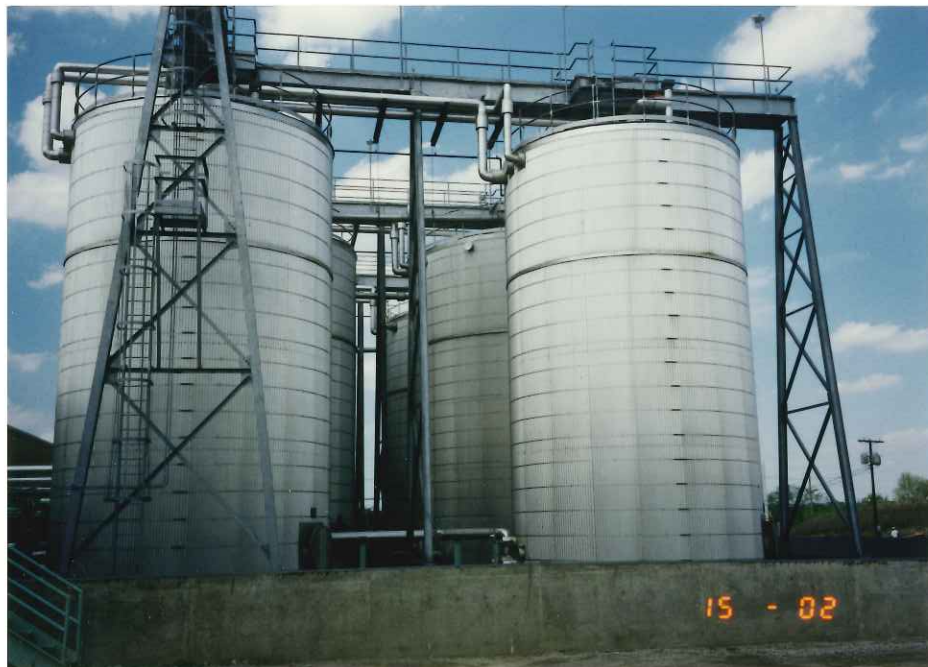
PHOTOGRAPH #14  
 OFFICIAL PHOTOGRAPH - JACOBS ENGINEERING  
 SUBJECT: Six T-Tanks inside concrete secondary containment  
 LOCATION: T-Tanks  
 DATE: 05/08/90                      TIME: 1502  
 PHOTOGRAPHER: L. Ehrhard  
 FILM: Kodacolor ASA 200  
 FILE: 10-E054-00  
 WITNESS: E. Gorove

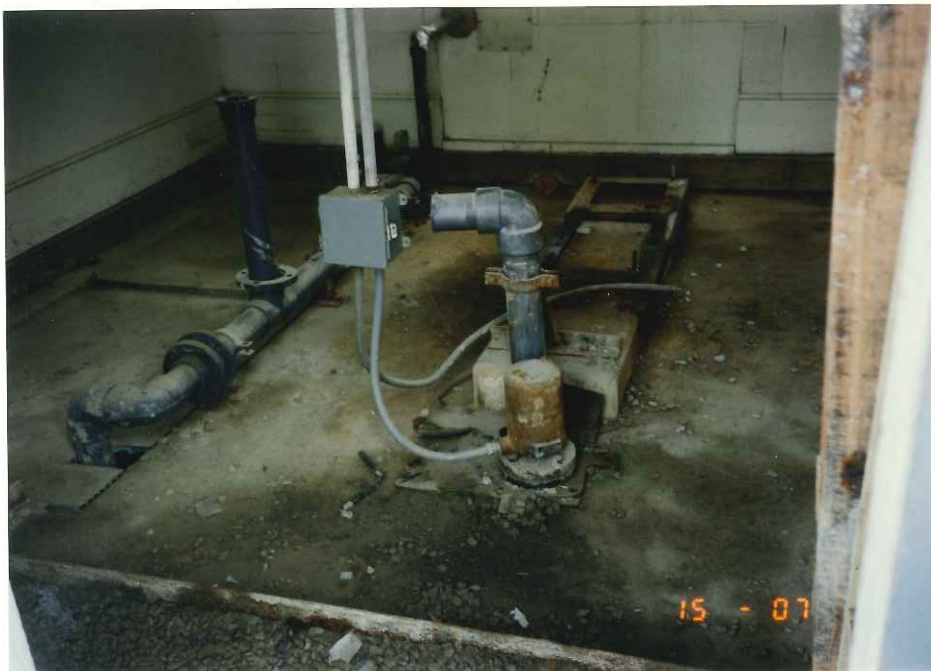
PHOTOGRAPH #15  
 OFFICIAL PHOTOGRAPH - JACOBS ENGINEERING  
 SUBJECT: Covered Sluice Pit inside building  
 LOCATION: Sluice Pit  
 DATE: 05/08/90      TIME: 1507  
 PHOTOGRAPHER: L. Ehrhard  
 FILM: Kodacolor ASA 200  
 FILE: 10-E054-00  
 WITNESS: E. Gorove

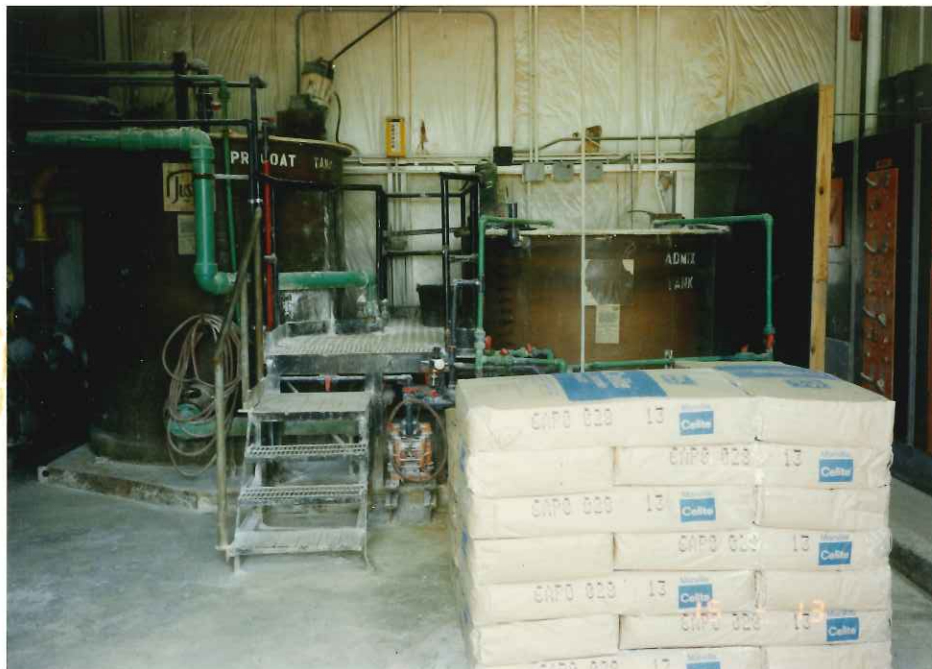
PHOTOGRAPH #16  
 OFFICIAL PHOTOGRAPH - JACOBS ENGINEERING  
 SUBJECT: Precoat and Admix Tanks in Filter Building #1  
 LOCATION: Filter Building #1  
 DATE: 05/08/90      TIME: 1513  
 PHOTOGRAPHER: L. Ehrhard  
 FILM: Kodacolor ASA 200  
 FILE: 10-E054-00  
 WITNESS: E. Gorove

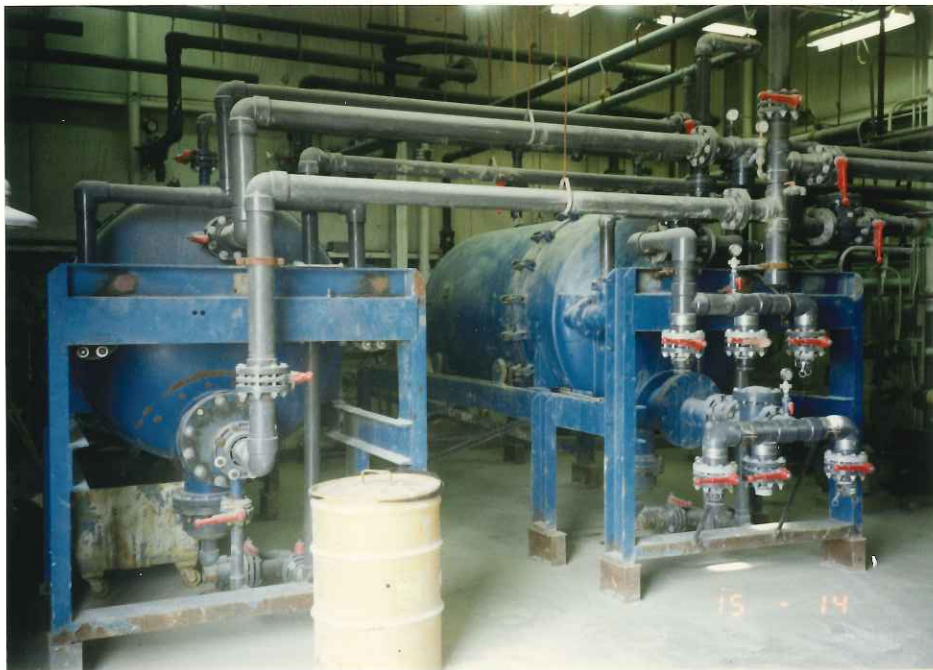
PHOTOGRAPH #17  
 OFFICIAL PHOTOGRAPH - JACOBS ENGINEERING  
 SUBJECT: Two Leaf Filters in Filter Building #1  
 LOCATION: Filter Building #1  
 DATE: 05/08/90      TIME: 1514  
 PHOTOGRAPHER: L. Ehrhard  
 FILM: Kodacolor ASA 200  
 FILE: 10-E054-00  
 WITNESS: E. Gorove

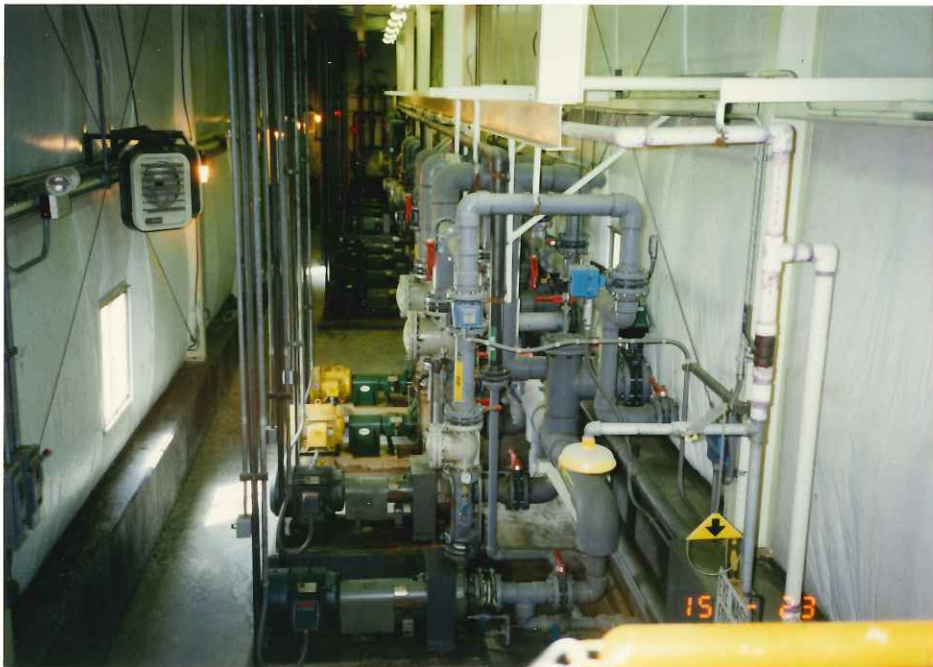
PHOTOGRAPH #18  
 OFFICIAL PHOTOGRAPH - JACOBS ENGINEERING  
 SUBJECT: Transfer pumps inside bermed housing  
 LOCATION: T-Tank Pumphouse  
 DATE: 05/08/90      TIME: 1523  
 PHOTOGRAPHER: L. Ehrhard  
 FILM: Kodacolor ASA 200  
 FILE: 10-E054-00  
 WITNESS: E. Gorove

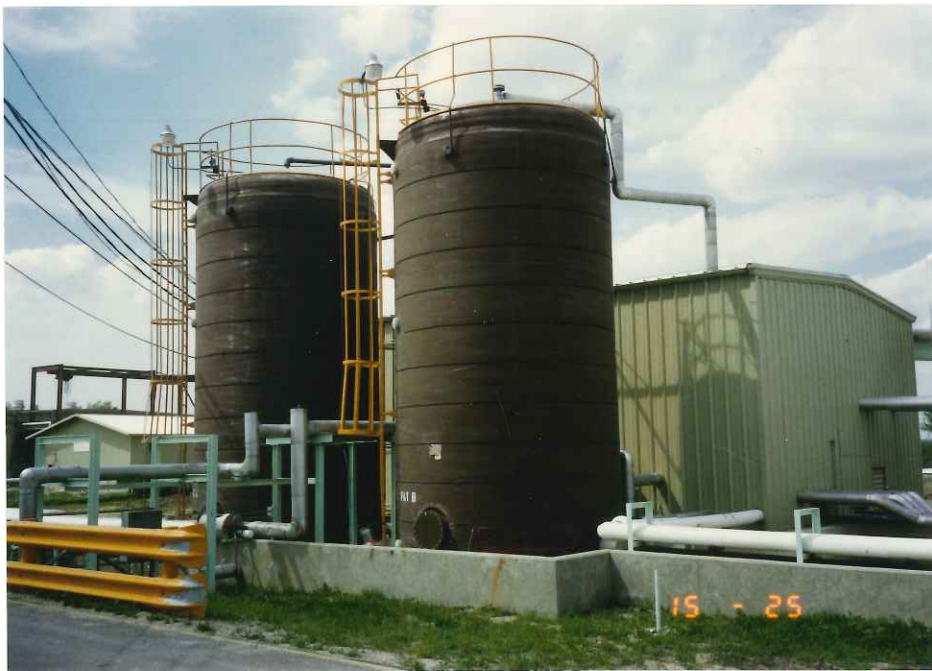
PHOTOGRAPH #19  
 OFFICIAL PHOTOGRAPH - JACOBS ENGINEERING  
 SUBJECT: FATs A and B in concrete secondary containment  
 LOCATION: FAT A and FAT B  
 DATE: 05/08/90                      TIME: 1525  
 PHOTOGRAPHER: L. Ehrhard  
 FILM: Kodacolor ASA 200  
 FILE: 10-E054-00  
 WITNESS: E. Gorove

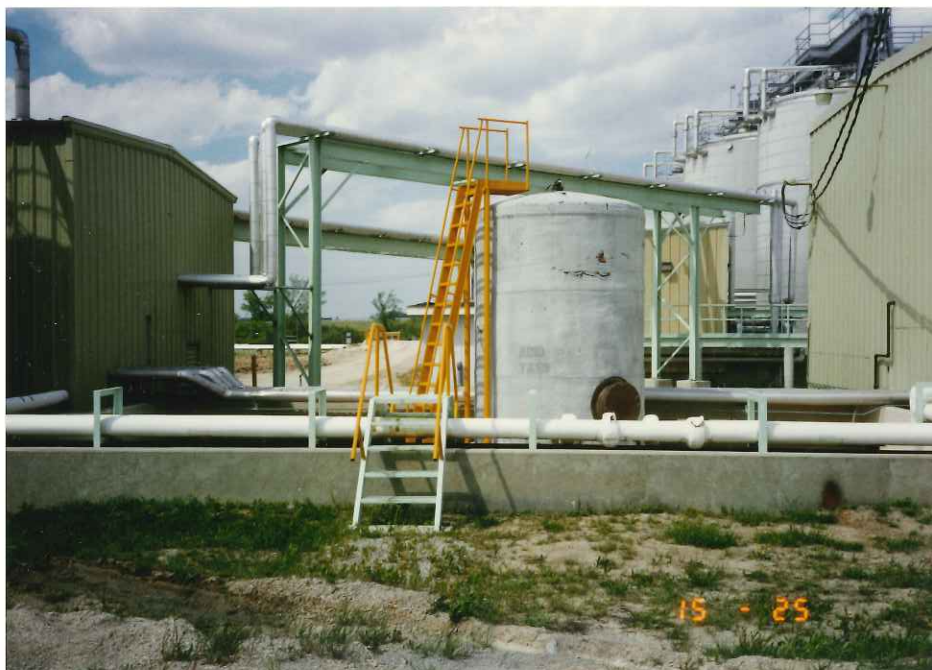
PHOTOGRAPH #20  
 OFFICIAL PHOTOGRAPH - JACOBS ENGINEERING  
 SUBJECT: FAT C in same concrete containment as FATs A and B  
 LOCATION: FAT C  
 DATE: 05/08/90                      TIME: 1525  
 PHOTOGRAPHER: L. Ehrhard  
 FILM: Kodacolor ASA 200  
 FILE: 10-E054-00  
 WITNESS: E. Gorove

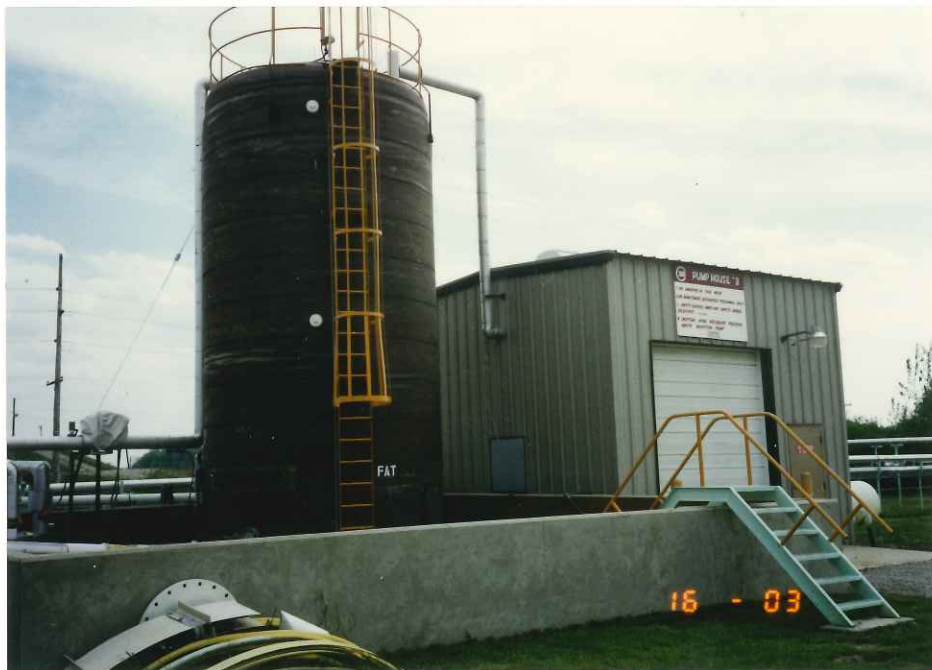
PHOTOGRAPH #21  
 OFFICIAL PHOTOGRAPH - JACOBS ENGINEERING  
 SUBJECT: FAT 3 in concrete secondary containment  
 LOCATION: FAT 3  
 DATE: 05/08/90 TIME: 1603  
 PHOTOGRAPHER: L. Ehrhard  
 FILM: Kodacolor ASA 200  
 FILE: 10-E054-00  
 WITNESS: E. Gorove

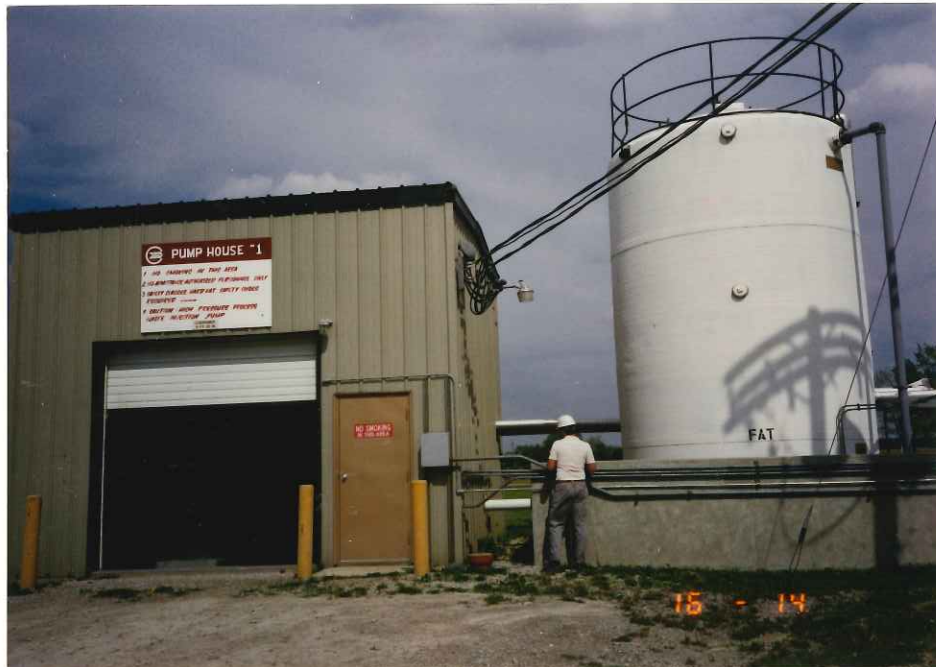
PHOTOGRAPH #22  
 OFFICIAL PHOTOGRAPH - JACOBS ENGINEERING  
 SUBJECT: Bermed FAT 1 next to Pump House 1  
 LOCATION: FAT 1/Pump House 1  
 DATE: 05/08/90 TIME: 1614  
 PHOTOGRAPHER: L. Ehrhard  
 FILM: Kodacolor ASA 200  
 FILE: 10-E054-00  
 WITNESS: E. Gorove

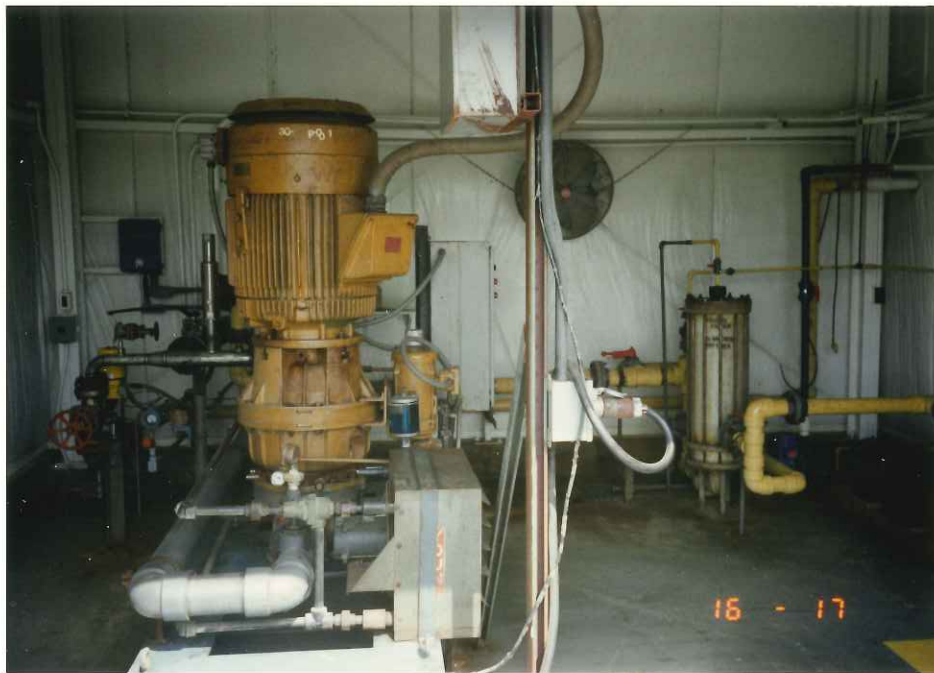
PHOTOGRAPH #23  
 OFFICIAL PHOTOGRAPH - JACOBS ENGINEERING  
 SUBJECT: One polish filter/one centrifugal pump in Pump House 1  
 LOCATION: Pump House 1  
 DATE: 05/08/90 TIME: 1617  
 PHOTOGRAPHER: L. Ehrhard  
 FILM: Kodacolor ASA 200  
 FILE: 10-E054-00  
 WITNESS: E. Gorove

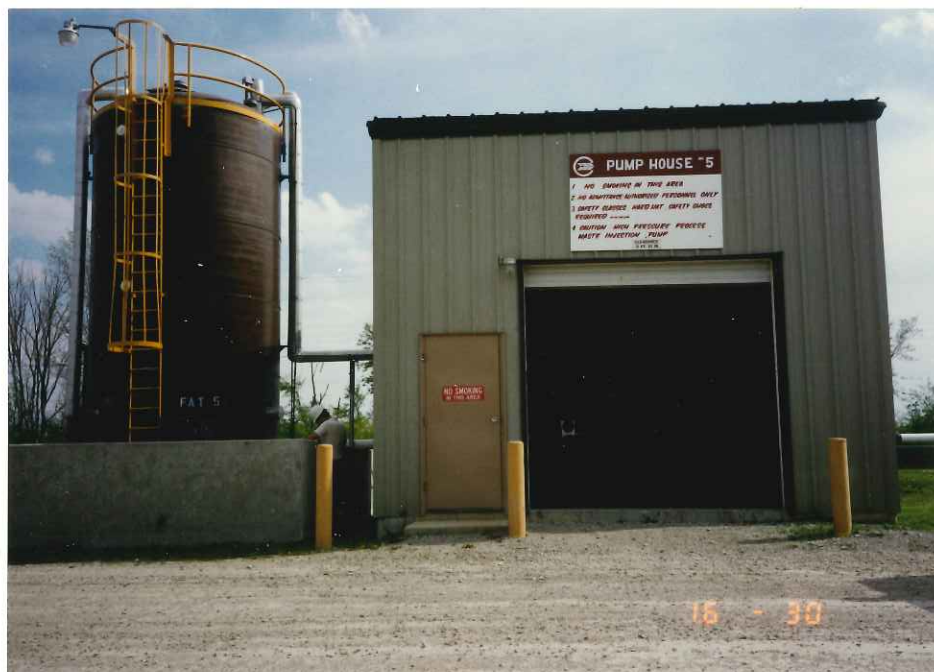
PHOTOGRAPH #24  
 OFFICIAL PHOTOGRAPH - JACOBS ENGINEERING  
 SUBJECT: Bermed FAT 5 and Pump House 5  
 LOCATION: FAT 5/Pump House 5  
 DATE: 05/08/90 TIME: 1630  
 PHOTOGRAPHER: L. Ehrhard  
 FILM: Kodacolor ASA 200  
 FILE: 10-E054-00  
 WITNESS: E. Gorove

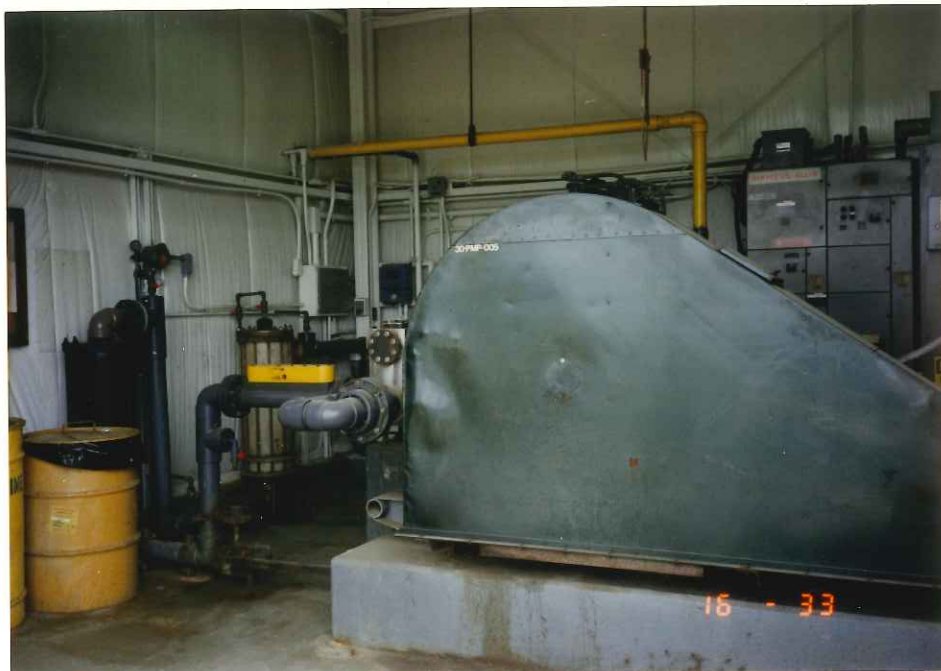
PHOTOGRAPH #25  
 OFFICIAL PHOTOGRAPH - JACOBS ENGINEERING  
 SUBJECT: Two polish filters/One piston pump in Pump House 5  
 LOCATION: Pump House 5  
 DATE: 05/08/90 TIME: 1633  
 PHOTOGRAPHER: L. Ehrhard  
 FILM: Kodacolor ASA 200  
 FILE: 10-E054-00  
 WITNESS: E. Gorove

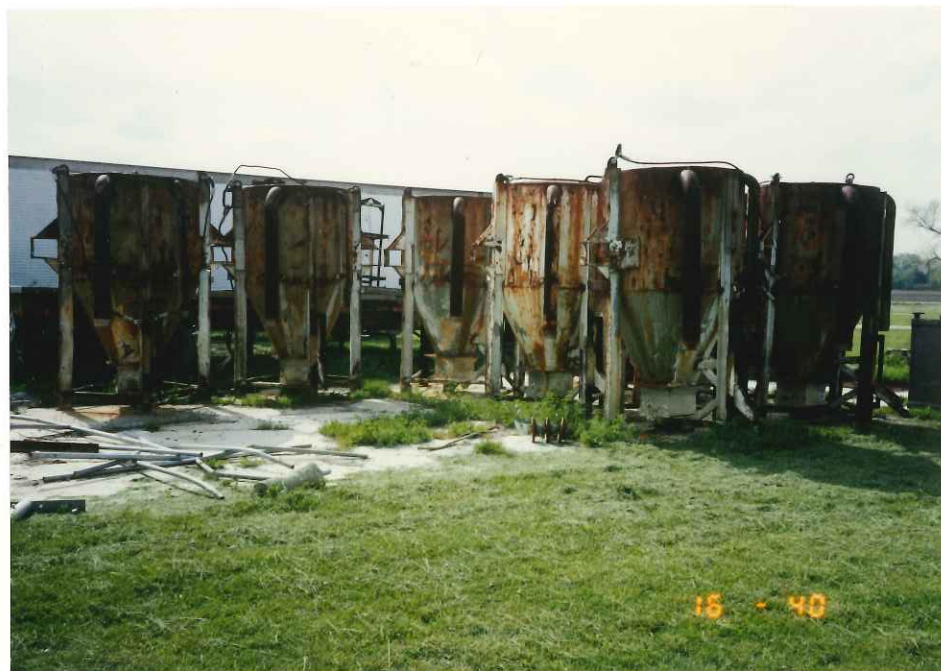
**G. VSI Observations:** No evidence of releases was observed. One of the hoppers had "PCB" etched on its side (photographs #26 and #27). The Pug Mill is located on the west side of the area (photograph #59).

PHOTOGRAPH #26  
 OFFICIAL PHOTOGRAPH - JACOBS ENGINEERING  
 SUBJECT: Eight kiln dust hoppers, decontaminated, on concrete storage pad  
 LOCATION: Hay Mill Area  
 DATE: 05/08/90 TIME: 1640  
 PHOTOGRAPHER: L. Ehrhard  
 FILM: Kodacolor ASA 200  
 FILE: 10-E054-00  
 WITNESS: E. Gorove

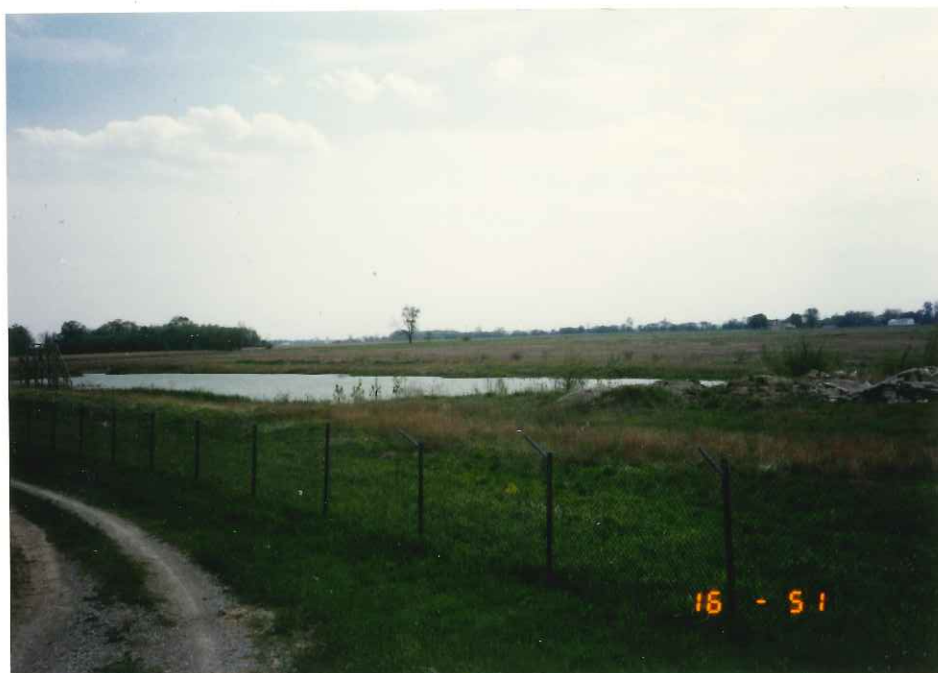
PHOTOGRAPH #28

**G. VSI Observations:** Demolition debris and rubble was observed at the north end of the Borrow Pit. Aerial photographs indicate that the debris was placed there after May 1985. CWM personnel did not know where the rubble came from. No stressed vegetation was observed. CWM personnel indicated that to their knowledge, no hazardous wastes were disposed of in the Borrow Pits (photograph #28).

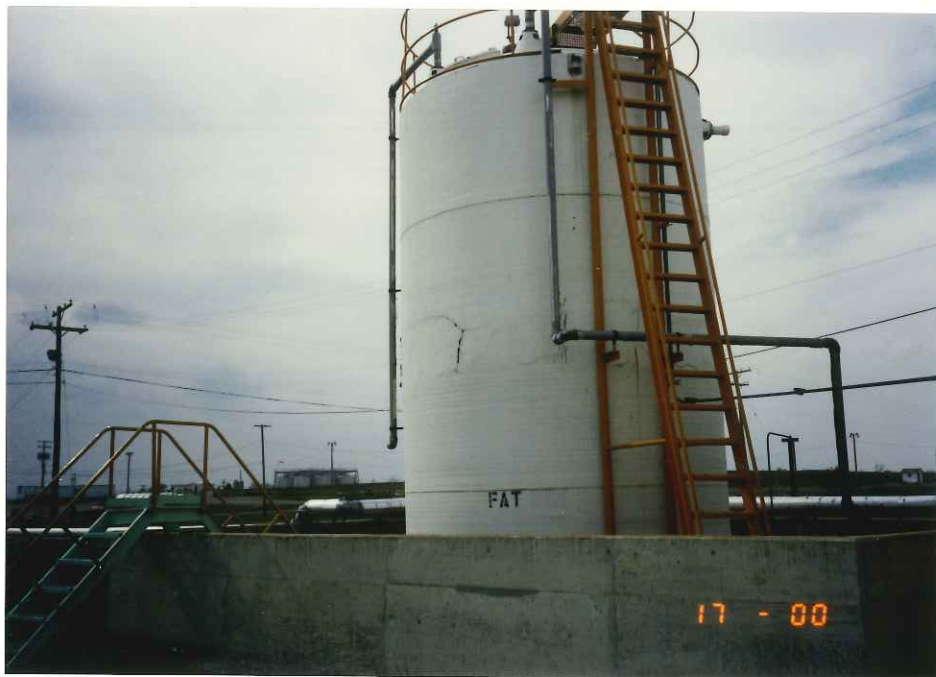
- G. **VSI Observations:** No evidence of releases was observed (photograph #29).
- H. **Sample Results:** None.
- I. **Suggested Further Actions:** No further action is required.

PHOTOGRAPH #29  
 OFFICIAL PHOTOGRAPH - JACOBS ENGINEERING  
 SUBJECT: FAT 2 with concrete secondary equipment  
 LOCATION: FAT 2  
 DATE: 05/08/90                      TIME: 1700  
 PHOTOGRAPHER: L. Ehrhard  
 FILM: Kodacolor ASA 200  
 FILE: 10-E054-00  
 WITNESS: E. Gorove

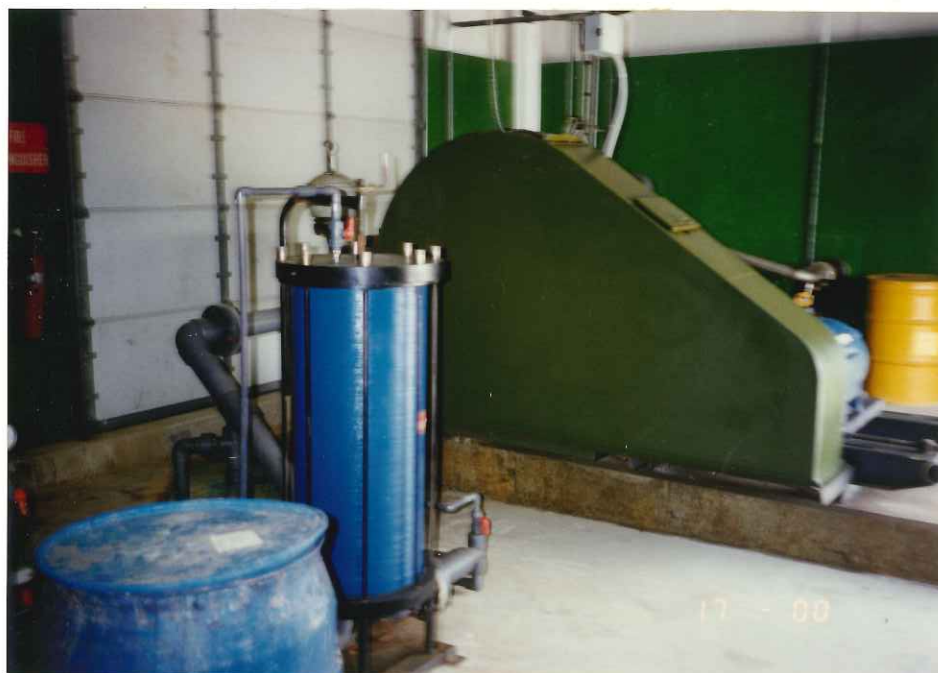
PHOTOGRAPH #30  
 OFFICIAL PHOTOGRAPH - JACOBS ENGINEERING  
 SUBJECT: One polish filter/one piston pump inside Pump House 4  
 LOCATION: Pump House 4  
 DATE: 05/08/90                      TIME: 1700  
 PHOTOGRAPHER: L. Ehrhard  
 FILM: Kodacolor ASA 200  
 FILE: 10-E054-00  
 WITNESS: E. Gorove

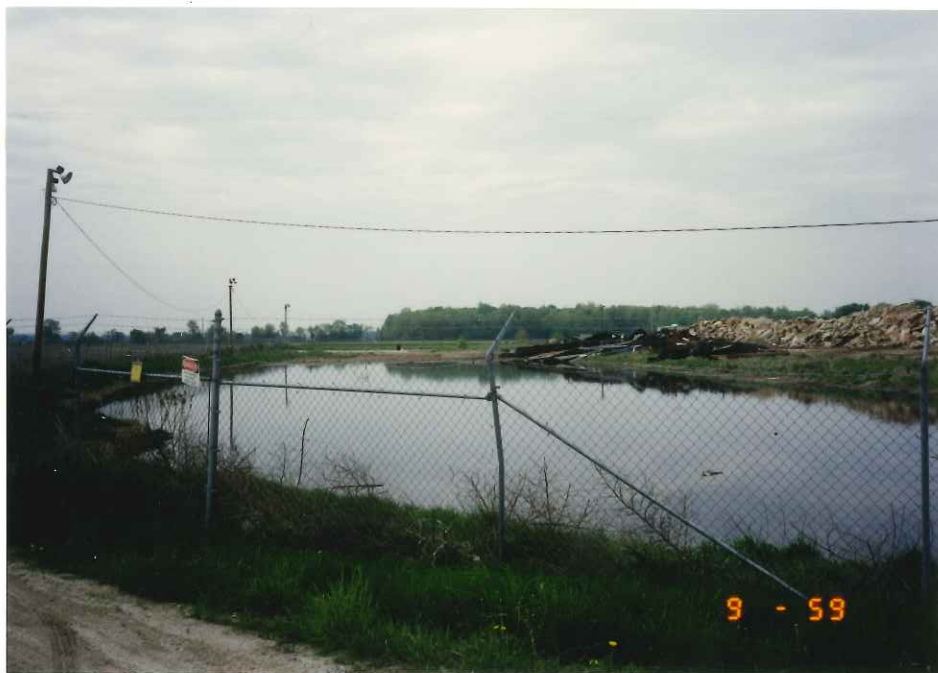
PHOTOGRAPH #31  
 OFFICIAL PHOTOGRAPH - JACOBS ENGINEERING  
 SUBJECT: North of Retention Pond looking south  
 LOCATION: Retention Pond  
 DATE: 05/09/90                      TIME: 0959  
 PHOTOGRAPHER: L. Ehrhard  
 FILM: Kodacolor ASA 200  
 FILE: 10-E054-00  
 WITNESS: E. Gorove

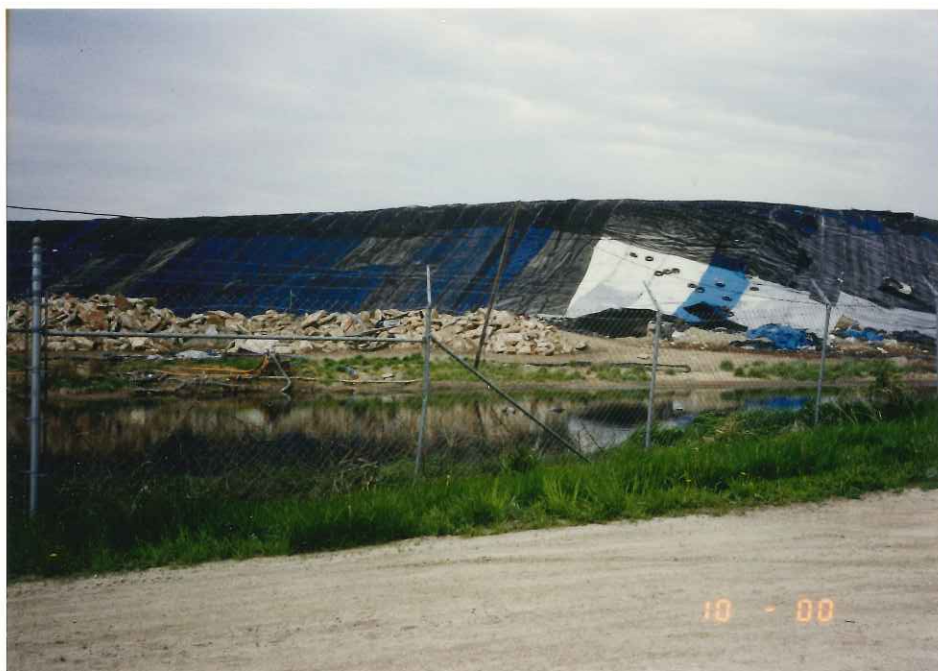
- G. **VSI Observations:** Pond 1 could not be observed because it has been backfilled and subsequently covered by the Waste Pile generated by the closure of Ponds 4, 5, and 7, and the Oil Reclamation Facility (photograph #32).

- G. VSI Observations:** Pond 2 could not be observed because it has been backfilled and subsequently covered by the Waste Pile generated by closure of Ponds 4, 5, and 7, and the Oil Reclamation Facility (photograph #32).
- H. Sample Results:** ETC analyzed soil and sludge samples from Pond 2 in 1983. The analyses indicated PCBs present in concentrations of 0-146 ppm. The PCBs are found in Sludges 3-12 feet below the top of the dikes [8, 9].
- I. Suggested Further Actions:** Continue groundwater assessment monitoring to evaluate migration of contaminants from SWMU.

- G. **VSI Observations:** Pond 3 could not be observed because it has been backfilled and subsequently covered by the Waste Pile (photograph #32).

PHOTOGRAPH #32  
 OFFICIAL PHOTOGRAPH - JACOBS ENGINEERING  
 SUBJECT: Retention pond, drainage pump, and Waste Pile in background  
 LOCATION: Retention Pond/Waste Pile  
 DATE: 05/09/90                      TIME: 1000  
 PHOTOGRAPHER: L. Ehrhard  
 FILM: Kodacolor ASA 200  
 FILE: 10-E054-00  
 WITNESS: E. Gorove

- I. **Suggested Further Actions:** If monitoring well L-19 is determined to be defective, it should be replaced. Continue groundwater assessment monitoring to evaluate migration of contaminants from Pond 1.

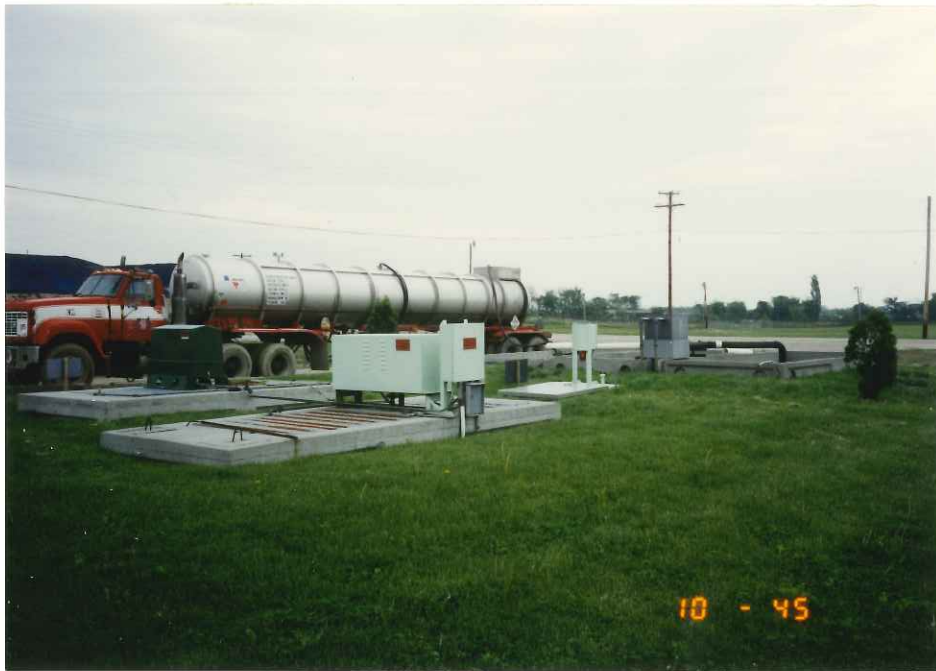
- G. **VSI Observations:** No evidence of releases was observed. Tanker truck off loads raw wastes pumped from cesspits and returns treated wastes to unloading facility for deep well injection (photograph #39).

PHOTOGRAPH #39  
OFFICIAL PHOTOGRAPH - JACOBS ENGINEERING  
SUBJECT: Underground sanitary wastewater treatment tanks and tanker truck  
LOCATION: Sanitary Wastewater Treatment Plant  
DATE: 05/09/90 TIME: 1045  
PHOTOGRAPHER: L. Ehrhard  
FILM: Kodacolor ASA 200  
FILE: 10-E054-00  
WITNESS: E. Gorove

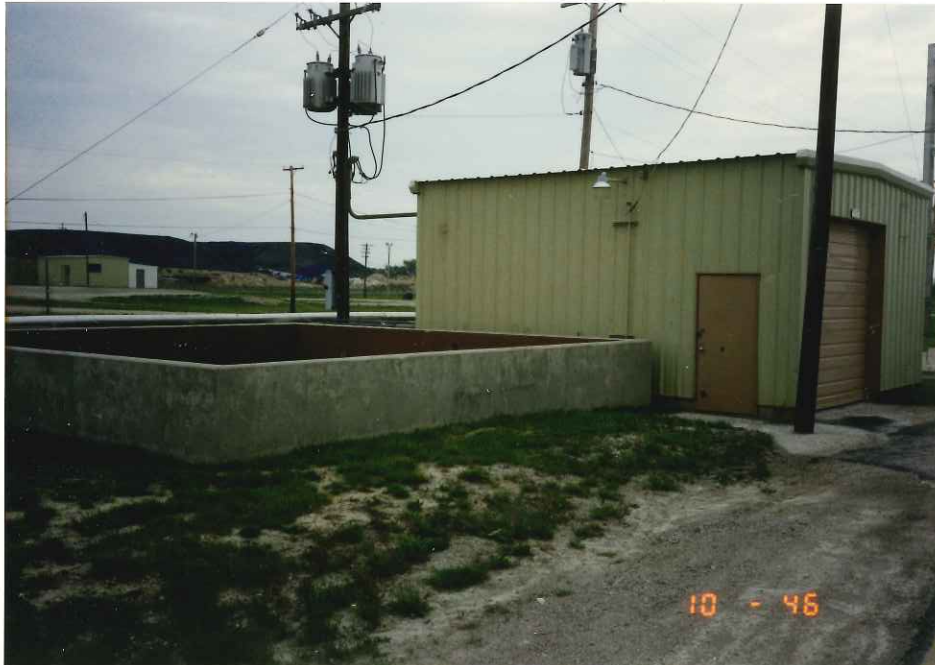
**Subsurface Gas**: There is a low potential for the generation and migration of subsurface gas.
- G. **VSI Observations**: 1-2 inches of liquid (probably rainwater) was observed in the secondary containment (photograph #40). ?

- G. **VSI Observations:** No evidence of releases was observed (photograph #40).
- H. **Sample Results:** None.
- I. **Suggested Further Actions:** No further action is required.

PHOTOGRAPH #40  
OFFICIAL PHOTOGRAPH - JACOBS ENGINEERING  
SUBJECT: Former secondary containment for FAT 2  
LOCATION: Former FAT 2 Containment/Pump House 2  
DATE: 05/09/90 TIME: 1046  
PHOTOGRAPHER: L. Ehrhard  
FILM: Kodacolor ASA 200  
FILE: 10-E054-00  
WITNESS: E. Gorove

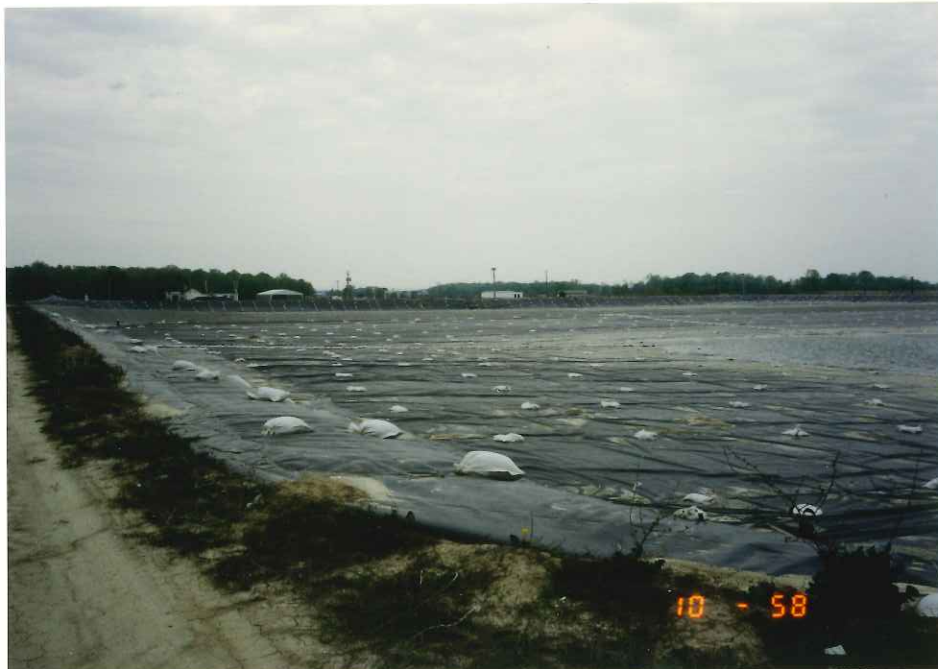
PHOTOGRAPH #42  
 OFFICIAL PHOTOGRAPH - JACOBS ENGINEERING  
 SUBJECT: Southeast half of Closure Cell from northeast corner  
 LOCATION: Former Ponds 4, 5, and 7/Closure Cell  
 DATE: 05/09/90                      TIME: 1058  
 PHOTOGRAPHER: L. Ehrhard  
 FILM: Kodacolor ASA 200  
 FILE: 10-E054-00  
 WITNESS: E. Gorove

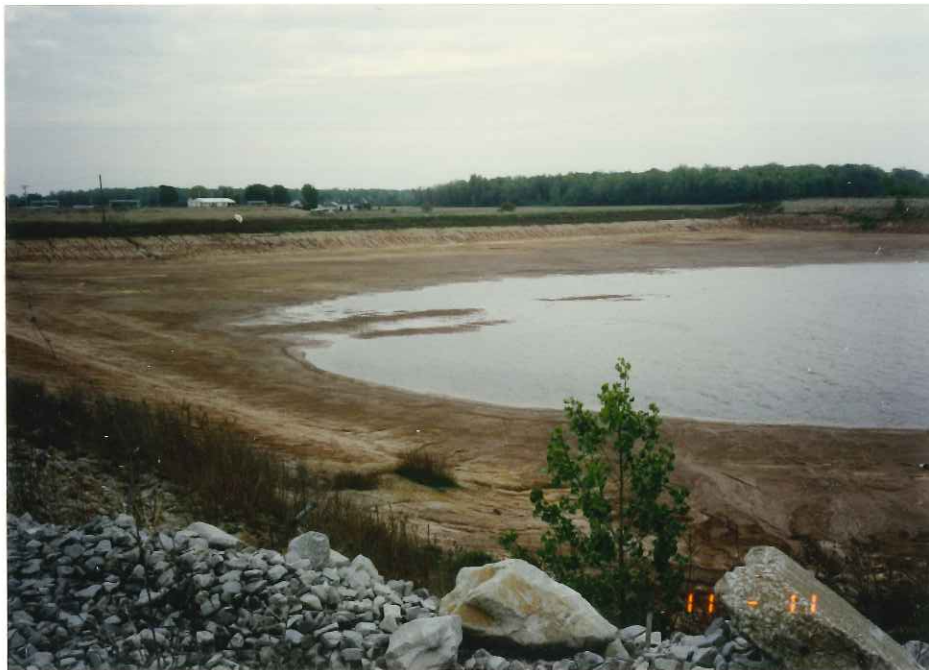
PHOTOGRAPH #45  
 OFFICIAL PHOTOGRAPH - JACOBS ENGINEERING  
 SUBJECT: Northeast half of Pond 12 from northwest corner  
 LOCATION: Pond 12  
 DATE: 05/09/90                      TIME: 1111  
 PHOTOGRAPHER: L. Ehrhard  
 FILM: Kodacolor ASA 200  
 FILE: 10-E054-00  
 WITNESS: E. Gorove

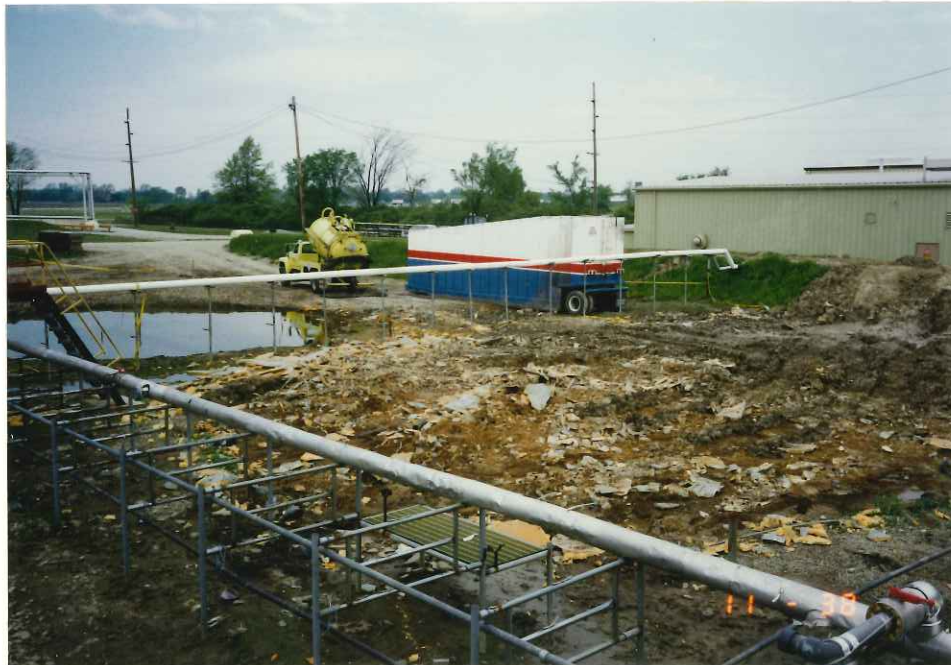
PHOTOGRAPH #50  
 OFFICIAL PHOTOGRAPH - JACOBS ENGINEERING  
 SUBJECT: Excavation beneath W-7, left, and deconstruction removal of W-5  
 LOCATION: Former W-Tanks  
 DATE: 05/09/90                      TIME: 1138  
 PHOTOGRAPHER: L. Ehrhard  
 FILM: Kodacolor ASA 200  
 FILE: 10-E054-00  
 WITNESS: E. Gorove

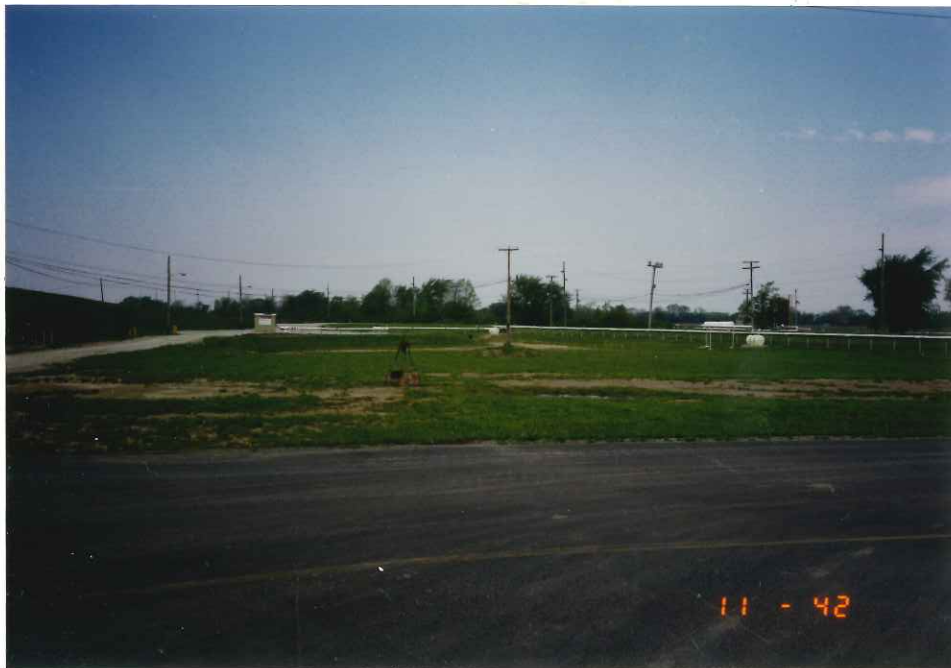
- G. **VSI Observations:** Approximately 2-3 feet of soil has been removed to the Waste Pile. However, a mound of soil at the base of a telephone pole still remains. Uneven grass growth was noted (photograph #51).

PHOTOGRAPH #51  
 OFFICIAL PHOTOGRAPH - JACOBS ENGINEERING  
 SUBJECT: West half of North Landfarm Area  
 LOCATION: North Landfarm Area  
 DATE: 05/09/90                      TIME: 1142  
 PHOTOGRAPHER: L. Ehrhard  
 FILM: Kodacolor ASA 200  
 FILE: 10-E054-00  
 WITNESS: E. Gorove
